The Uttarakhand Himalayan region of Yamunotri and Janki Chatti is ripe for a catastrophe similar to that which befell Kedarnath in 2013.

Aniruddha Uniyal¹

Abstract

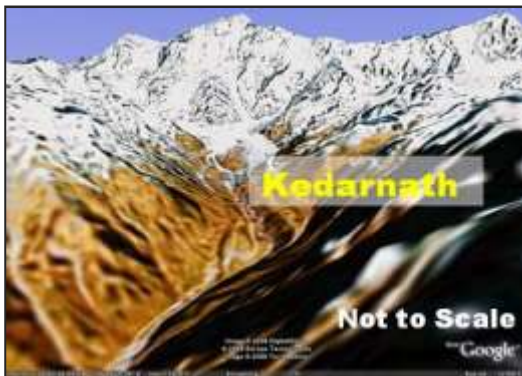
Figure 1a: 3-Dimensional view based on a satellite image of Kedarnath area (after www.earth.google.com; Image ©2008 DigitalGlobe; Europa Technologies; Terra Metrics).

the entry point of the 14 km long pony route to Kedarnath prior to the June, 2013 deluge. Ram Mandir is a transit point on the Janki Chatti - Yamunotri pony route similar to Rambara on the Gaurikund - Kedarnath pony route. According to Jain et al (2007) the source of the Yamuna River is Yamunotri Glacier. Champasar Glacier located on the Kalind Mountain at a height of 4,421 m above sea level, about 1 km further up from Yamunotri shrine, has also been referred to as the source of the Yamuna River (<http://en.wikipedia.org/wiki/Yamunotri>) (Figure 2a). This is similar to the Kedarnath area which is drained by the Mandakini River which originates from the Chorabari Glacier (Dobhal et al., 2013) (Figure 1a).

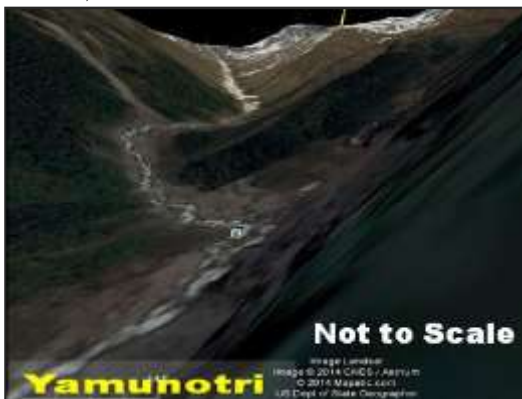
Figure 2a: 3-Dimensional view of the upstream area of Yamunotri based on a

satellite image (after www.earth.google.com; Image © 2014 CNES / Astrium © Mapabc.com US Dept of State Geographer).

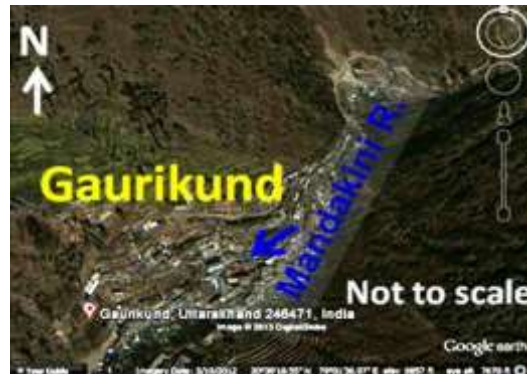
Figure 1b: Pre disaster satellite image of Gaurikund (after www.earth.google.com; Image © 2013 DigitalGlobe).

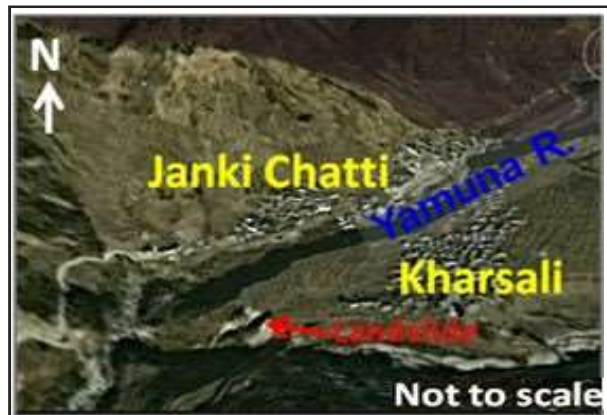
Figure 2b: Satellite view of Janki Chatti and Kharsali (after www.earth.google.com Image © 2014 CNES / Astrium © Mapabc.com US Dept of State Geographer).

downstream of Yamunotri) in close proximity to the Yamuna River and also the uncontrolled floating population of pilgrims has drastically increased the vulnerability of Janki Chatti (Figure 2b & j).

Yamuna River (Figure 2h). In Janki Chatti bank protection is required on the right bank of the Yamuna River and further downstream on both banks at Kharsali bridge and Janki Chatti vehicle parking area (Figure 2b & j). Located opposite to Janki Chatti the village of Kharsali is approximately 7 km downstream of Yamunotri and is a gently sloping spacious area on raised terrace in this otherwise narrow upper Yamuna valley. Further, Kharsali has the last helipad in the Yamuna valley and it serves as the only air link to Yamunotri (Figure 2b). Toe walls and wire crates are also required as structural mitigation measures for stabilizing the parallel and sub parallel landslide zones developed down slope of Kharsali village on the left bank of the Yamuna river. Phul Chatti - Janki Chatti stretch of the Rishikesh - Yamunotri Highway (opposite Kharsali on the right bank of the Yamuna River) needs additional protection to minimize erosion during flash floods. Critical slopes and old slide material at Ram Mandir restricts the capacity of this transit point (to Yamunotri) to accommodate the construction of restaurants.

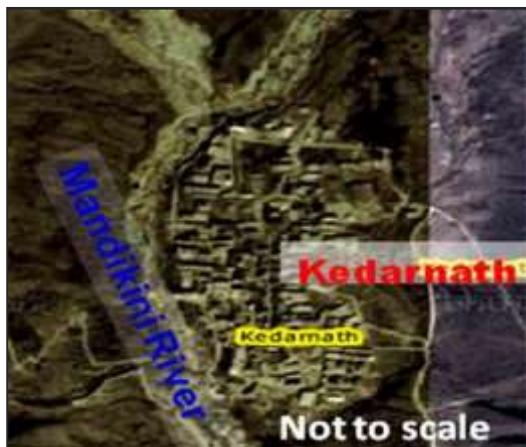
Figure 1c: Pre disaster satellite image of Kedarnath (after NRSC website bhuvan-noeda.nrsc.gov.in).

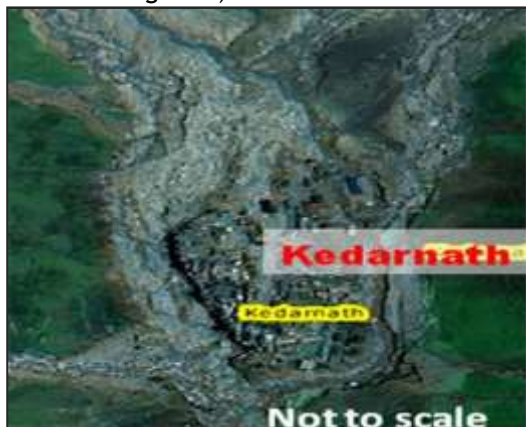
Figure 1d: Post disaster satellite image of Kedarnath showing devastation by flash flood and attendant debris flow (after NRSC website bhuvan-noeda.nrsc.gov.in).

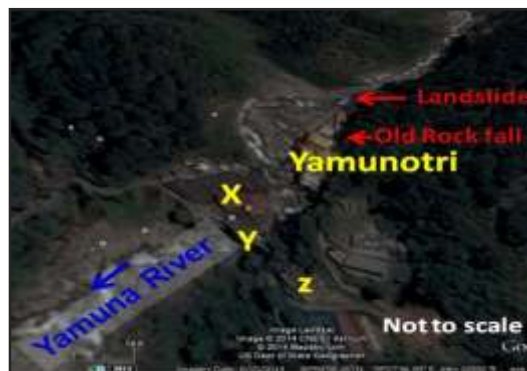
Figure 2c: Satellite view of Yamunotri (after www.earth.google.com ; Image © 2014 CNES / Astrium © Mapabc.com US Dept of State Geographer; 'X' is showing location of temporary shops, 'Y' is showing the location of bridge & 'Z' is showing the location of Kali Kambli Dharamshala the only lodge in Yamunotri.

the unremitting spate of the Yamuna River (in the event of a major flood) and might hinder the spread of flood water, which then might rise to a high level thereby posing a severe risk to the Yamunotri Temple and the bridges immediately downstream and also to the temporary shops selling items for religious rituals at Yamunotri Temple (Figure 2c, e & h).

At Yamunotri moderately steep to steep and at some spots even critical hill slopes and flash flood prone reaches of the Yamuna river hardly provide space for commercial construction (Figure 2c,d,e,h). Temporary shops near the iron bridge across the Yamuna River at Yamunotri are prone to landslides from upslope hill side and flash floods and toe erosion along the river (Figure 2c & e) and hence, should be shifted to a relatively safer site on the left bank somewhere near Kali Kambli Dharamshala (Figure 2c). Apart from this, new commercial constructions should neither be allowed around Kali Kambli Dharamshala nor on the banks of the Yamuna River immediately downstream of Yamunotri Temple. Further,

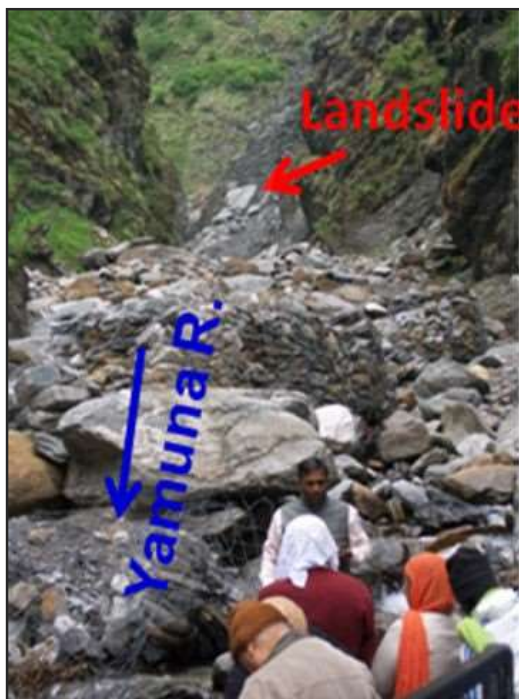
Figure 2d: Active landslide on the left bank valley wall of the Yamuna River about 50 meters upstream of Yamunotri Temple.

witnesses active tectonics and high seismicity. Further, these phenomena in conjunction with high rainfall coupled with hill slope toe erosion drastically enhance the probability of large landslide events in this part of the river valley. Uniyal et al (2012), reported an active translational rock slide about 50 meters upstream of Yamunotri temple on the left bank valley wall of the Yamuna River in an area where the river flows through a narrow gorge. Further activation of this slide zone and other such active slide zones upstream of Yamunotri Temple might block the flow of the river and this in turn may result in the creation of a lake immediately upstream of Yamunotri Temple (Figure 2d).

structural mitigation measures should be taken immediately to stabilize the active rock slide zone on the left bank of the Yamuna river (about 50 meter upstream of Yamunotri Temple) in order to avoid (in the near future) obstruction of the Yamuna River and probable formation of a lake, the outburst of which would cause havoc in Yamunotri and downstream.

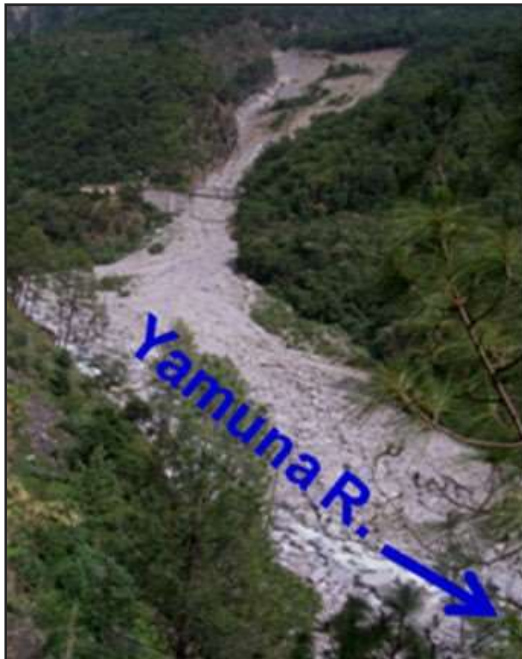
Figure 2f: Torrential rain fall induced Saina Chatti landslide in upper Yamuna valley.

In the upper Yamuna valley the Saina Chatti landslide (with funnel shaped scarp and elongated lobe) some 18 km downstream of Janki Chatti, is an evidence of torrential rainfall induced landslides (Figure 2f). Lack of instrumental rainfall data makes it difficult to authenticate whether this (Saina Chatti) landslide is cloud burst induced or not. However, discussion with locals in Saina Chatti confirmed heavy rains during this slide event. The above evidence of extreme weather events in the Yamuna valley during the recent past indicates a strong probability of torrential rains or even cloud burst induced devastating flash floods and landslides in the Yamunotri - Janki Chatti area and downstream areas of Saina Chatti, Kharadi and Gangani which are located on

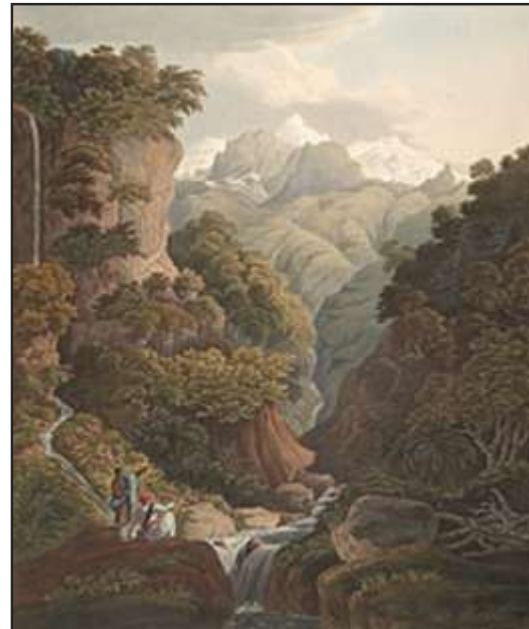
Figure 2g: No construction activity in Yamunotri as depicted in 1820 by James Baillie Fraser (<http://en.wikipedia.org/wiki/Yamunotri>).

Construction activity at Yamunotri during recent times has transformed it from a shrine with no construction to one with ill conceived constructions and this in turn has drastically enhanced the physical vulnerability of Yamunotri shrine to flash floods, landslides and earthquakes (Figure 2g & h). At Yamunotri the 'V' shaped narrow valley with unstable hill slopes provides, virtually no spare space for further construction (Figure 2e). Rampant construction activity for commercial purposes in the Janki Chatti area (some 6 km

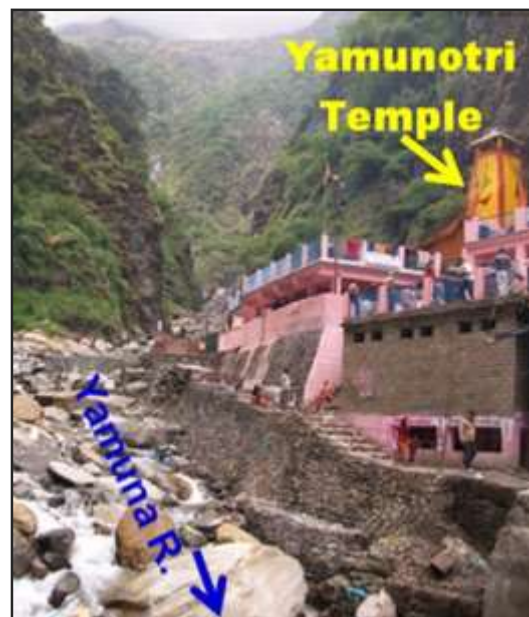
Figure 2h: Present day field view of Yamunotri Temple.

very high flood hazard prone old flood plain and lower terraces of the upper Yamuna River valley. Yamunotri Temple is presently witnessing toe erosion by the Yamuna River and, to mitigate it, wire crates and large cement blocks have been placed on the river side of the temple. This temple is similar to a four to five storied building constructed on the lower terrace or old flood plain of the River Yamuna that may be flooded again in near or far future (Figure 2h).

Additional bank protection is required near Yamunotri Temple on the left bank of the

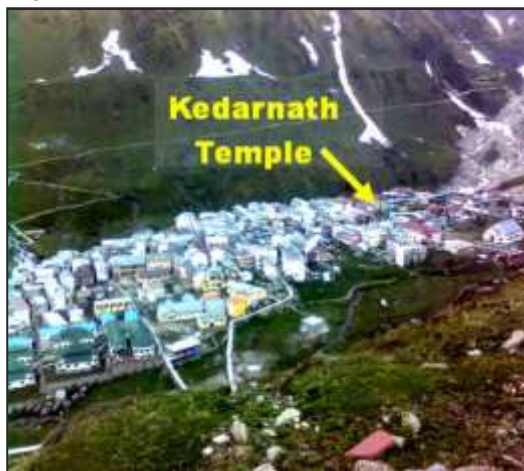
Figure 1e: May, 2013 Pre disaster Panoramic view of Kedarnath some 20 days before the tragedy (Photograph by class xth student Ashutosh Tripathi).

The topographic similarities between Yamunotri - Janki Chatti and Kedarnath - Gaurikund can be depicted in the form of their narrow 'V' shaped valleys with moderately steep hill slopes and high gradient of both rivers (the Yamuna as well as Mandakini). Further, both river valleys witness heavy rainfall during the monsoon season. The hydro-geological and hydrometeorological scenario in the upper Yamuna valley bears some resemblance to the Kedarnath area and further, the narrower width of the Yamuna valley and probability of landslide damming and lake formation are even more than in the Mandakini valley (Figure 1a; 2a, c & d). This keeps alive the possibility of a Kedarnath like flash flood coupled with debris flow and or mobilization of glacial material, in the case of an extreme climatic event such as torrential rains in the upper catchment of the Yamuna River (Figure 1e,f; 2e,h).

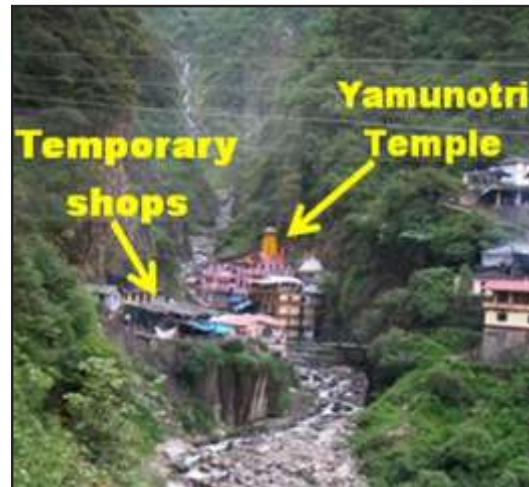
Figure 2e: Present day field view of Yamunotri shrine.

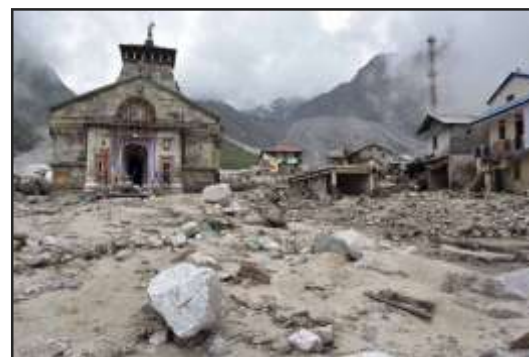
Figure 1f: Field view of Kedarnath after flash floods and debris flow slides of June, 2013 (after <http://www.google.co.in>; <http://blogs.outlookindia.com>).

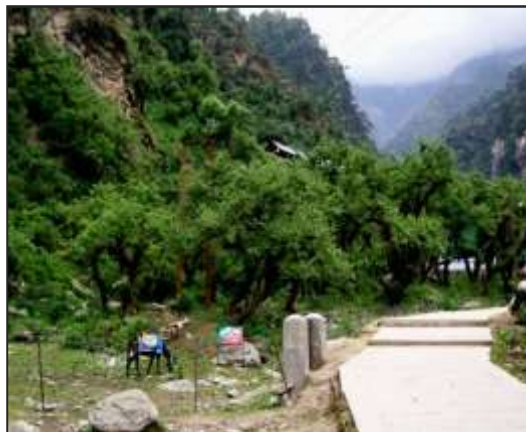
Figure 2i: Part of Yamunotri - Janki Chatti pony route passing through severe flood hazard prone old flood plain of Yamuna River at Sita ki Vatika (Smriti Van).

Further downstream on the Janki Chatti - Yamunotri pony route the floating population of pilgrims is at highest risk at Sita ki Vatika (immediately upstream of Janki Chatti) where the pony route passes through a severe flash flood hazard prone old flood plain of the Yamuna River (Figure 2i).

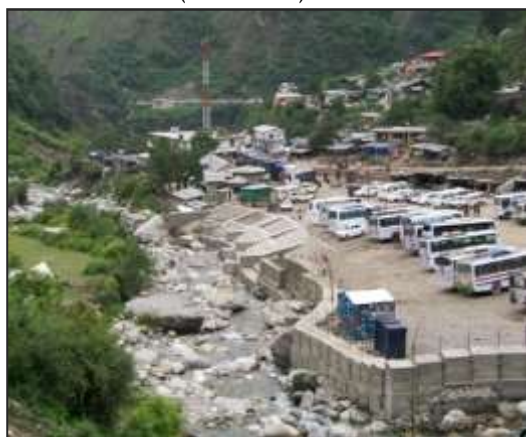
Figure 2j: Vehicle parking at Janki Chatti on the right bank of the Yamuna River on its lower terrace is at risk of flash flood.
