## Dagupan River, Pangasinan, Philippines: Morphology and Channel Changes

### Abstract

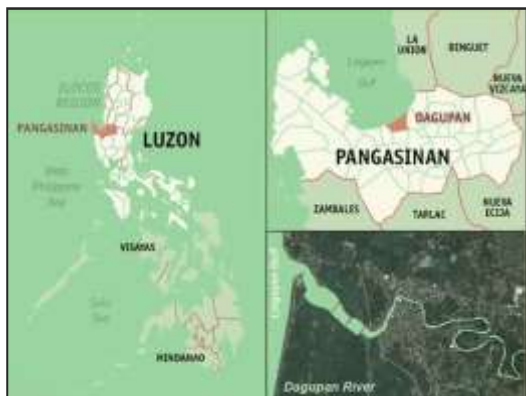
morphological characteristics of terrain features, and monitoring effects of flooding as well. Dagupan river upstream originates from Benguet and passes through San Manuel, Binalonan and Urdaneta City and finally feeding Lingayen Gulf (Figure 1). Owing to the presence of large tract of grassland in highly elevated part of the watershed of Dagupan river is considered degraded in nature. With its steep slopes, erodible soils as well as geological instability can be attributed to the current climate change phenomenon manifested by high rainfall intensity.

**Figure 1:** Dagupan River, Pangasinan, Philippines.

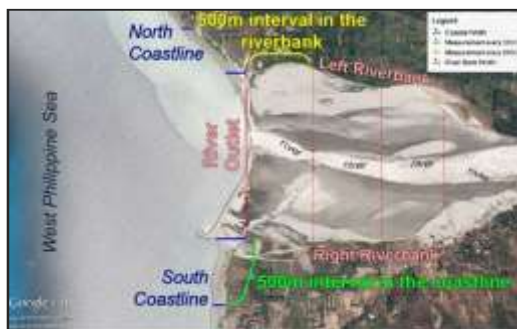
Satellite images of the Google Earth from years 2004 to 2013 of Dagupan river in Pangasinan, were used for the analysis to identify changes. Satellite images of the river outlet, riverbank and coastlines were selected and analyzed quantitatively (Figure 2). Moreover, the actual measurements were done in September 2015. The methodology used in collecting data in different sites such as river outlet, riverbank and coastlines are as follows:

**Figure 2:** Image analysis of Google Earth Satellite Imageries.

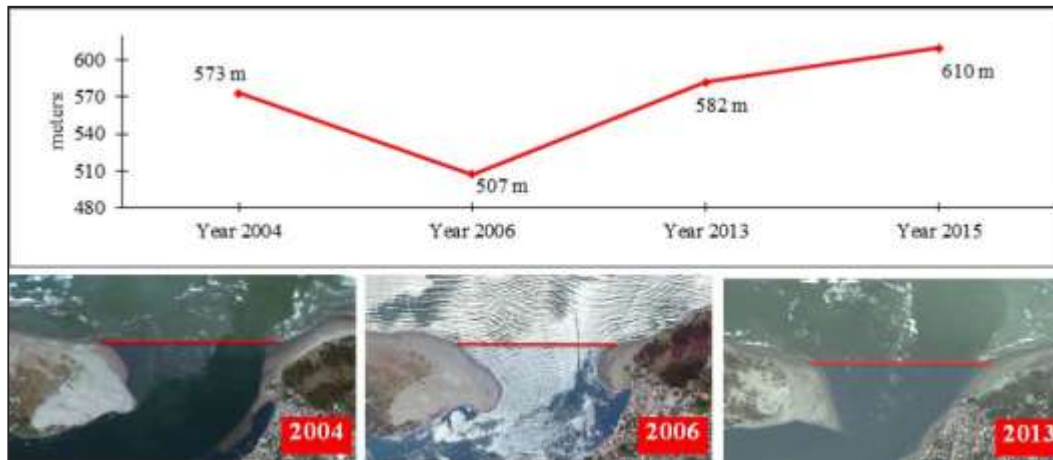
Dagupan river outlet increased in width size in a span of 9 years. It decreased in size in year 2006 from 573 meters to 507 meters but eventually increased again in size in 2013 from 507 to 582 meters. During the field measurement in 2015, the river outlet increased in size from 582 meters to 610 meters (Figure3). Erosion and accretion were both observed in the area and these

Figure 3: Width of Dagupan River outlet measured in different years.

processes maybe the reasons for the river outlet changes and these also may be due to huge number of fish cages installed in the

area because fishing is the primary source of livelihood of the local communities near the study area.

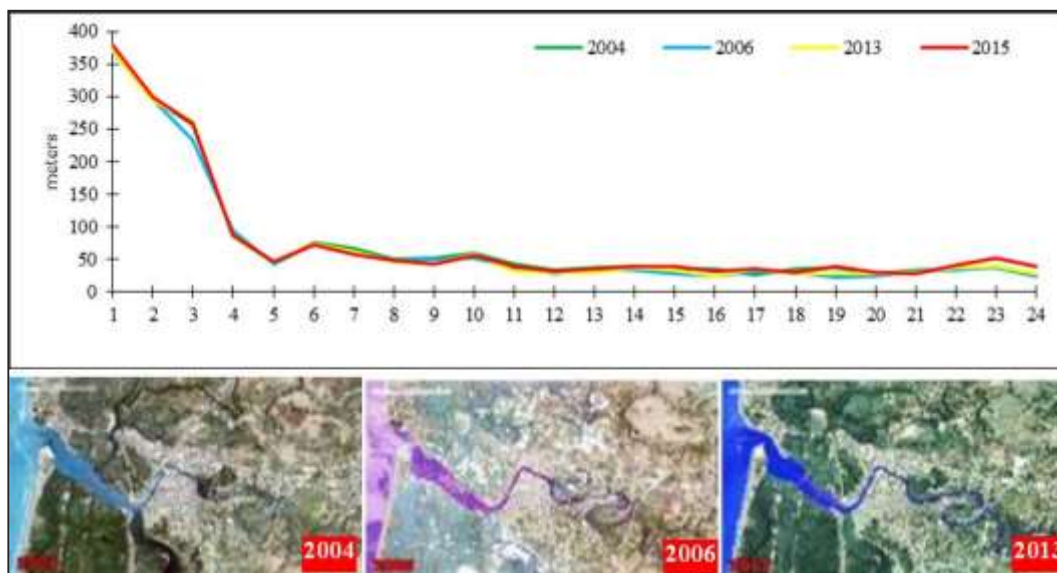
Dagupan River slightly increased its width during the period of 2004 to 2015 (Figure 4).

Figure 4: Width of Dagupan Riverbank measured in different years.

Frequent flooding due to heavy rains in conjunction with the release of water in San Roque dam directly affects the river morphology the river. However, the presence of fish pens/cages alongside the riverbank artificially holds the soil and the riverbank from further erosion. The data from National Disaster Risk Reduction and Management Council (NDRRMC Preparedness Measures, 2015), indicates that the fish cages can help hold the soil and decrease the river flow but can easily be destroyed during typhoons that in turn may cause millions of milk fishes to escape in the open waters just like in Dagupan.

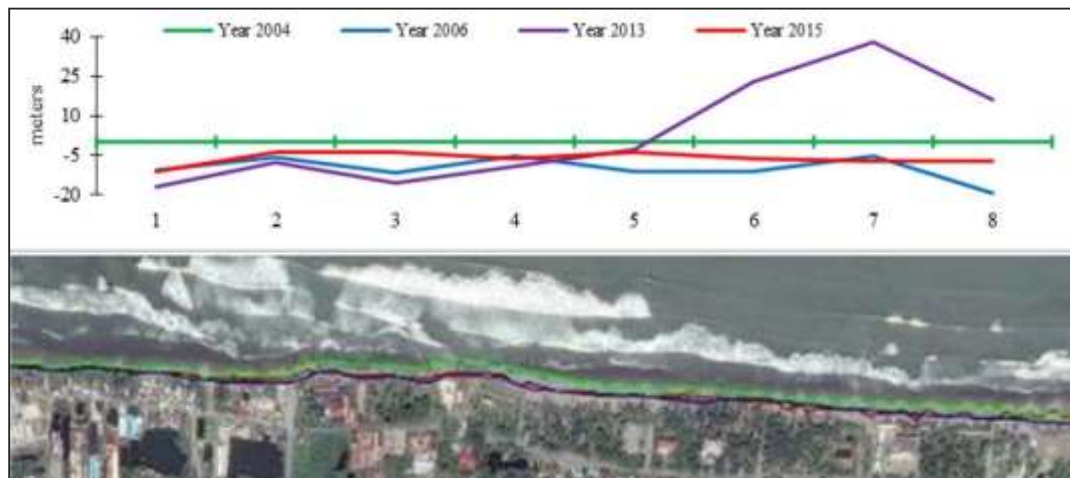
The measurement of the North Coastline nearby Dagupan River from 2004 to 2015 is demonstrated in the Figure 5. Erosion and accretion were observed in the area; Points 1 to 5 on the coast were detected to be eroded in the years 2006, 2013 and 2015 while points 6 to 8 accreted in the year 2013. Outlet of the river shows that coastal erosion usually occurs near the outlet. The area was reportedly hit by several typhoons every year which cause damages and natural changes in the area. The residents described how strong typhoons affected their everyday living when heavy rains cause severe flooding and also sand storm which sometimes limits visibility in the area thereby

Figure 5: North coastline changes from 2004 to 2015.

causing the dry eyes. It was observed that severe flooding became a serious problem for the residents in the area and are getting worse when stored water from the dam is released downstream. However, during high tides, the waves which rise up to 4 meters constantly carry the sand from the sea. The beach level lowers drastically which enables larger waves to reach as far as the sandbank. Erosion in the coastal area of Dagupan could be the result of the consistent calamities and disasters experienced by the area every year. The Department of Environment and Natural Resources - Region 1 reported that the north easterly wind is more prominently influenced by the sediment transport and

coastal drifting as is evident by the fifty (50) hectares accreted land and convex shape shoreline near the Dagupan river (Coastal Geo-hazard Survey, 2013). These findings perhaps maybe due to the effects of accretion of sand which was observed in the coast near the Dagupan river outlet apparently in the last points of the North coast of the Dagupan river. From point 6 up to the last point of the coast, the beach was very wide due to the accumulation of sand and sediments coming from San Fabian river which is in parallel to the Dagupan river located up north. This limits the energy of waves which are weaker when they reach the back shore (Dehouck, 2014).

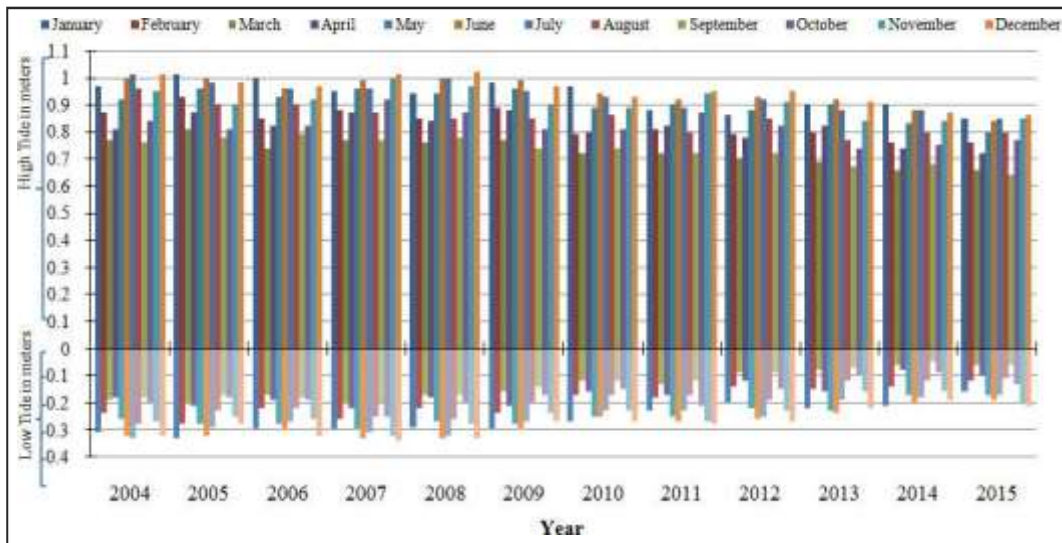
Figure 7: Tide table-peak measurement per year at Bolinao, Pangasinan.

**Analysis of Sea Level Rise in Pangasinan**  
The graph shown in Figure 7 is a decadal scale data from Bolinao Philippines tide chart (Online Tides World View, 2016). It provides tide predictions for over 7000 places around the world. Bolinao tide table-peak measurement predictions per year which

represent the tide level measurements in the coastal areas of Pangasinan indicate that, average level of low tides in Pangasinan Gulf is increasing overtime. The average low tide in 2004 (-0.098 m) and the average low tide in 2015 (-0.045) had an average difference of 0.053 meter in terms of water level. The

water level in the recent years (2013, 2014 & 2015) is nearer to land area than in the year 2004. However, the level of high tides in the year 2010 to 2015 is lower as compared to that in the years 2004 to 2009. As the level of low tides increases, the level of high tides decreases. The trend, linked to global warming, puts thousands of coastal cities, even whole islands at risk of being claimed by the ocean (Folger, 2013). Over the past century, the burning of fossil fuels and other human and natural activities has released enormous amounts of heat-trapping gases into the atmosphere. These emissions have caused the Earth's surface temperature to rise, and the oceans absorb about 80 percent of this additional heat. The rise in sea levels is linked to three primary factors, all induced by this ongoing global climate change such as thermal expansion, melting of glaciers and polar ice caps, and ice loss from Greenland and West Antarctica (Folger, 2013).
